Aggregate and Concrete Petrography

Insights into Aggregate, Concrete, and Issues that can affect their Performance

April Snyder – RJ Lee Group, Inc.

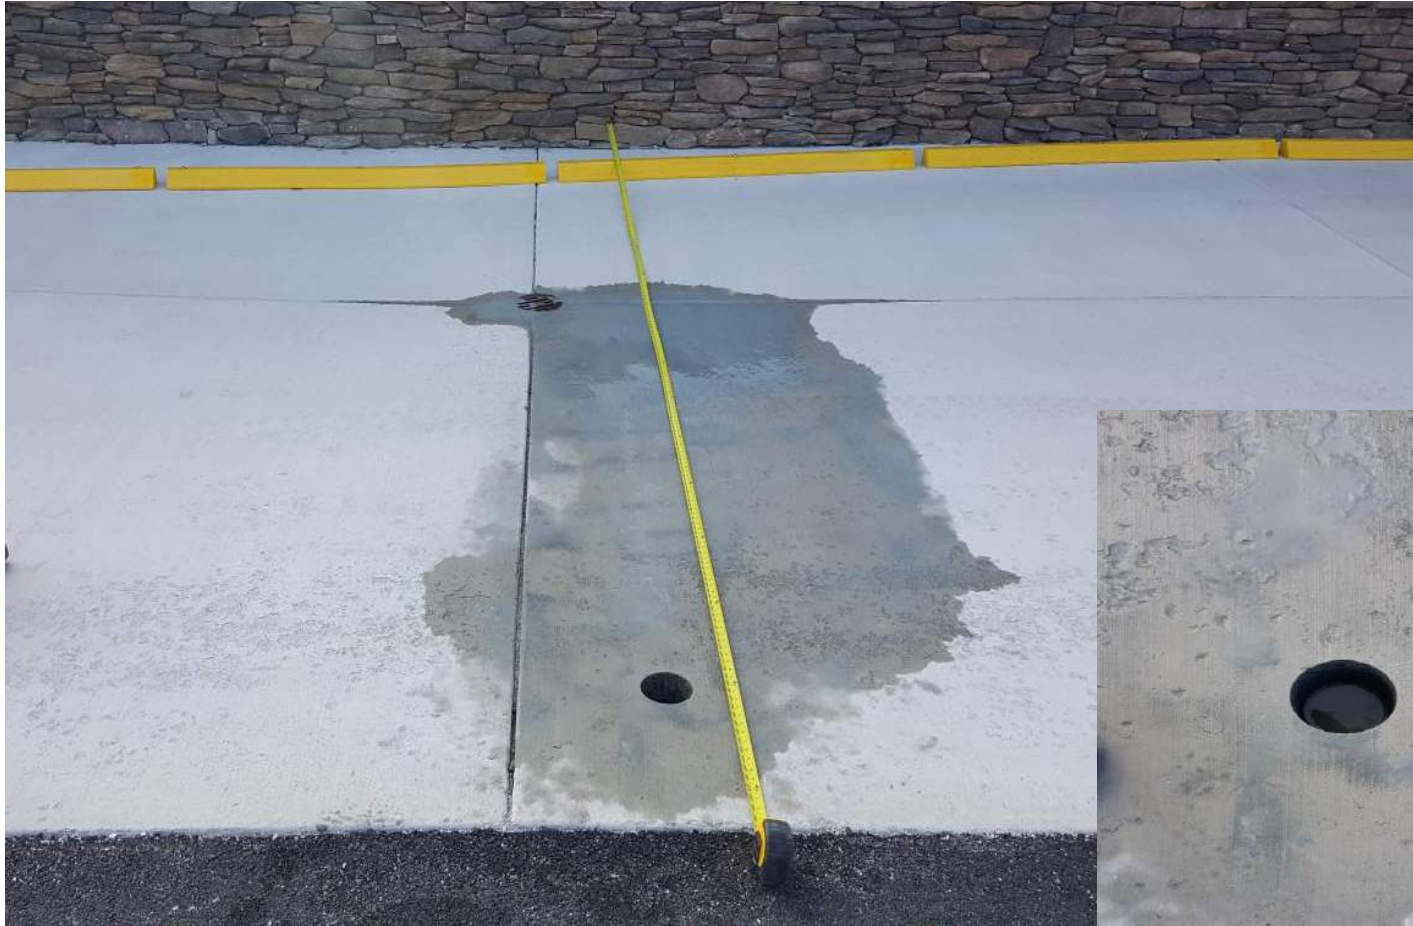
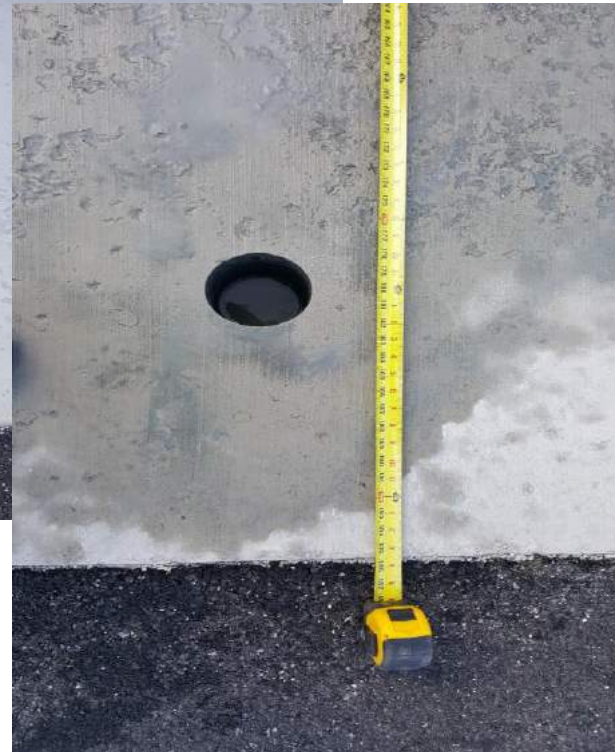
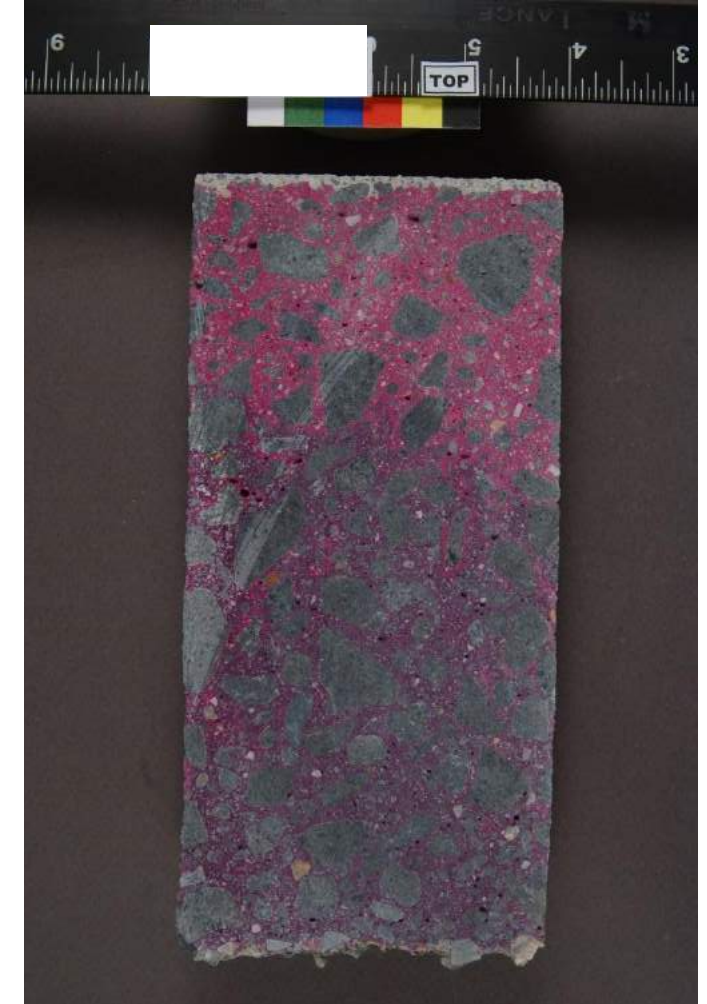
Increased W/Cm-ratio at surface

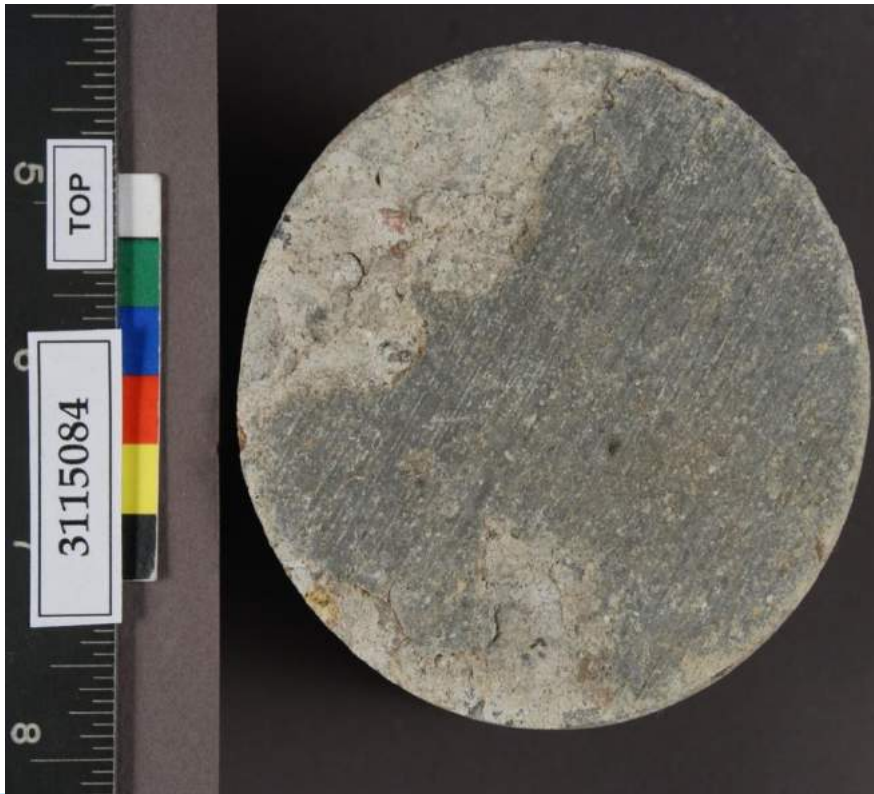
Surface Distress: Scaling

Due to Freeze thaw damage caused by
Over working during finishing causing a decrease in
air content in top 1/8" of surface.

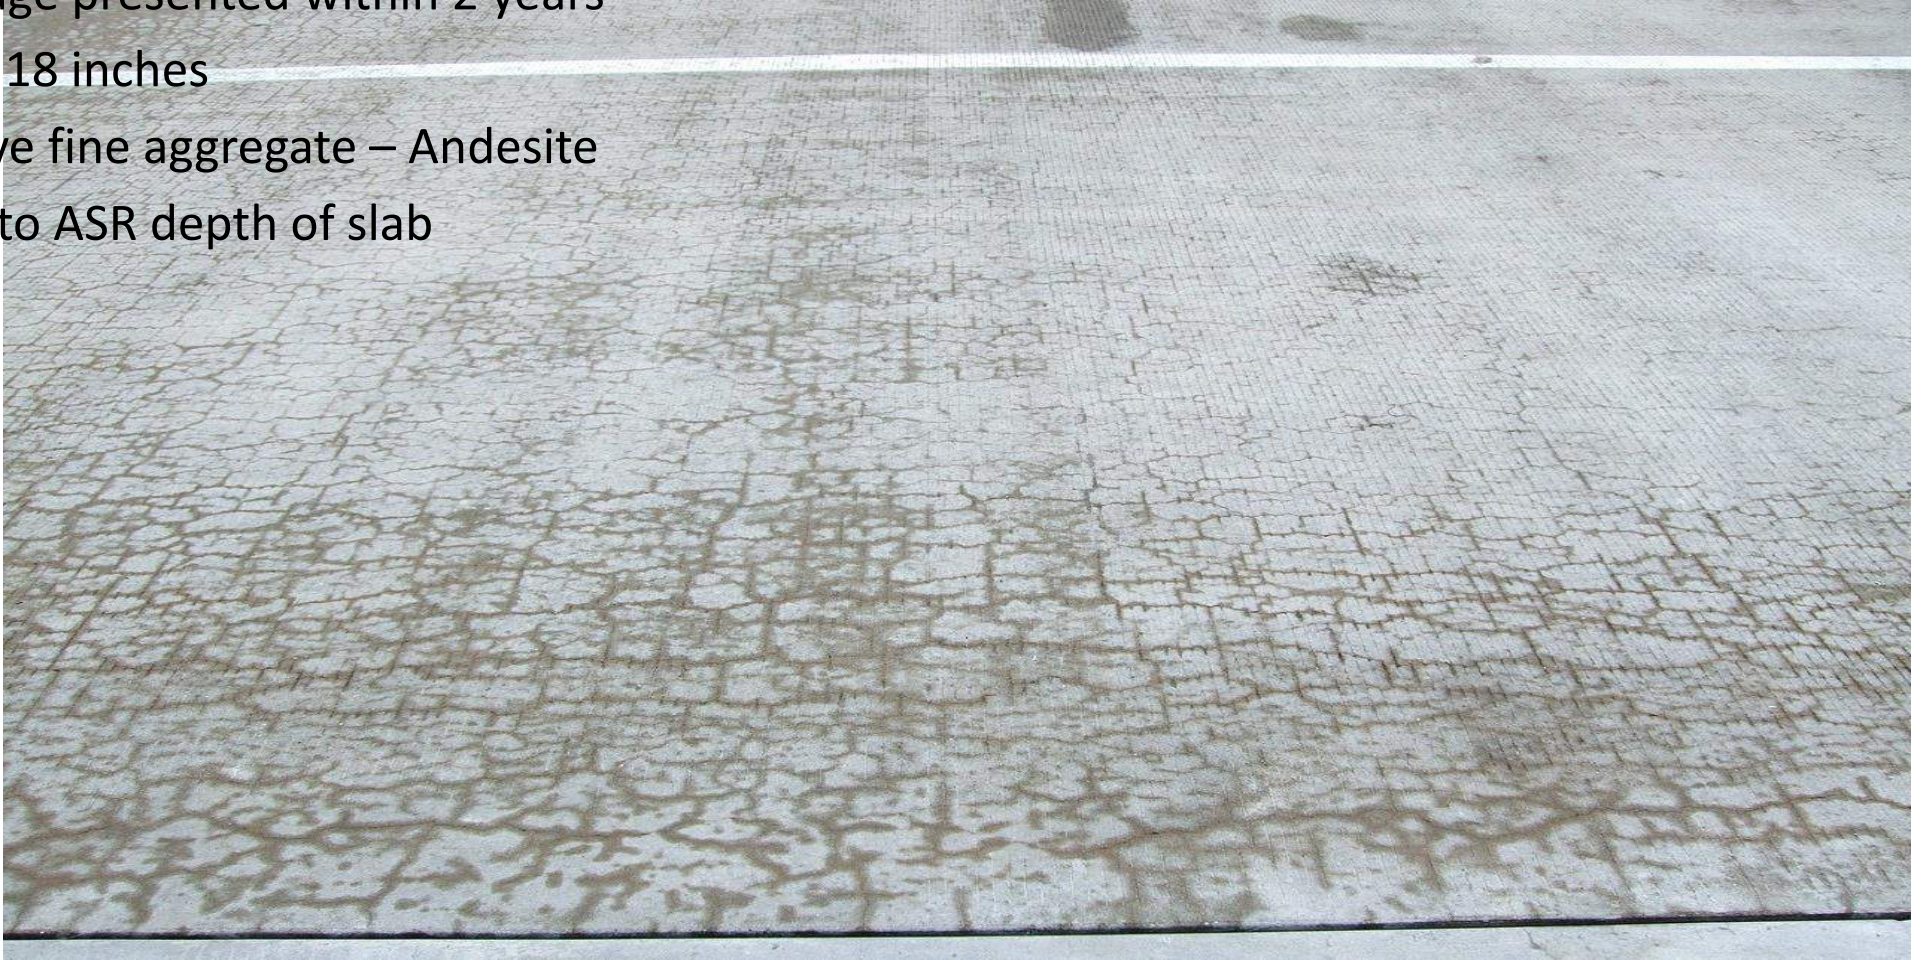
Alkali Silica Reaction Case Study

- Airport runway tarmac placed in 2010
 - ASR damage presented within 2 years
- Slab depth of 18 inches
- Highly Reactive fine aggregate – Andesite
- Cracking due to ASR depth of slab
